Structural type Open type jetty		Case No. CAM-1		Inspection data		
Port	Sihanouk Ville port	Completion	1959		Component	Method
Name of facility	Old Jetty	Service start	1960		All Structure	Visual Check
Management body	Port Autonomous of Sihanouk ville	Tidal level	H.W.L	1.9	m	Date
			L.W.L	0.3	m	Aug-95
		Design water depth	-9	m

The target of the facility is Open type jetty. Which had been in service for 50 years. the old jetty consists of three part: Main jetty , access bridge , and corner junction located in between the former structures. since the Jetty P/C beam was seriously damage by the splash of waves, and lack of maintenace. After repaired work in 1996, The jetty handling only the general cargos and passenger cruise ship.

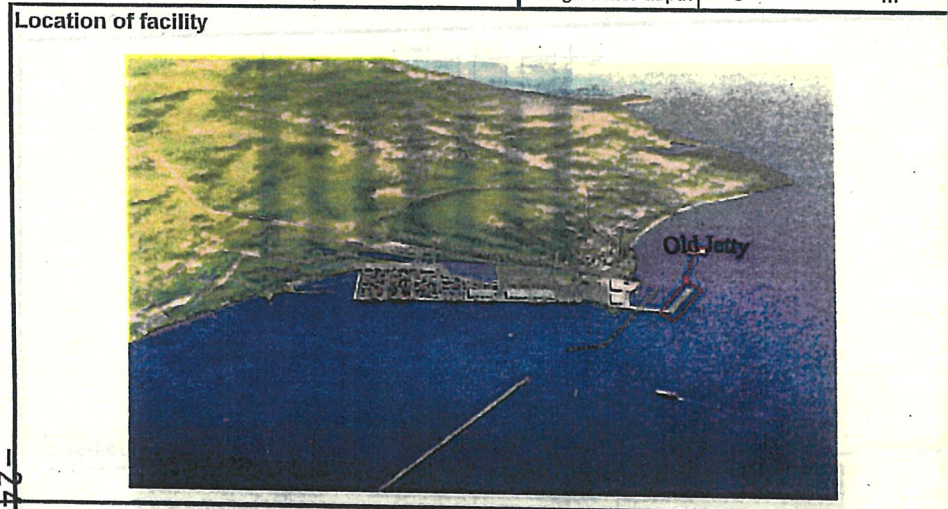
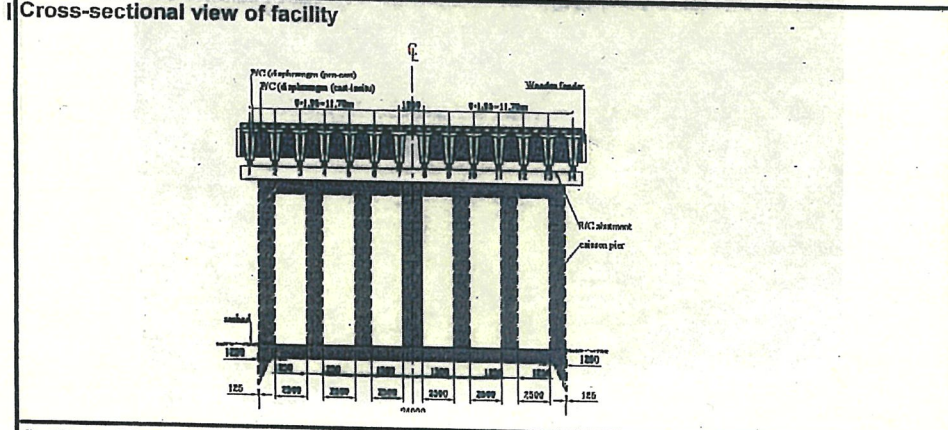
(Comments)
 The repaired Beam in 1996 was Cracked and damaged along the bottom of it. the corrosion appeared on Steel plate and the steel bar. Some H-Shape Steel structure of the fenders are Deformed and the wooden was fell down.

The concrete cracking and spalling out by the continue corrosing of the steel bar.

Some of Fenders are Deformed and corroded the wooden cannot reduce the impact of the ship force:

Remove the spoiled concrete and clean the surface, cut the corroded bar and replacing with the new painted Deform bar by welding and use the Steel plated.

Cut and remove the Deform H-Shape Steel, and then replace with new H-Shape steel that connected by Bolt. The woodens are replaced by used Stacker tyres.

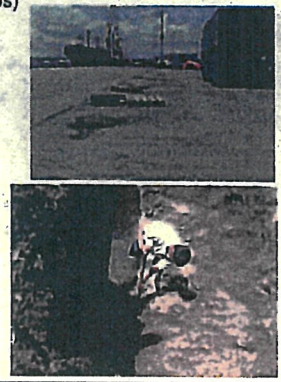
(Comments)
The absence of geotextile filter fabric on the upper portion of the rock containment bulkhead due to settlement gave way for the fill materials to scour out through the voids of the rocks. The voids between the rocks permit the exit of fill materials from the back-up area. The continuous tidal variation and the repeated action of the sea waves on the rock bulkhead structure tend the fill materials to scouring and consequently settled the elevation of the back-up area.

(Comments)
Gravel base top pavement and fill materials are excavated to reveal the actual elevation of settled geotextile fabric. The excavation is continued 1.0 meter below the existing geotextile fabric to provide a minimum lapping of 1.0 meter between the existing and the new geotextile fabric. The large voids between the armour rocks are filled with smaller core rocks so as not to over-stress the geotextile from holding the fill materials against the large voids. The new geotextile fabric is installed up to elev. +2.00m to secure its position from another possible settlement. Fill materials and base course materials are re-placed and compacted to design elevation prior to pouring of new concrete pavement. Periodic survey and inspection along the area is being programmed by PMO-General Santos to monitor any possible settlement in the future.

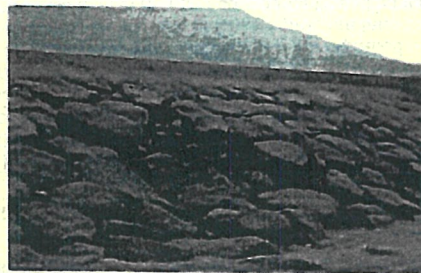
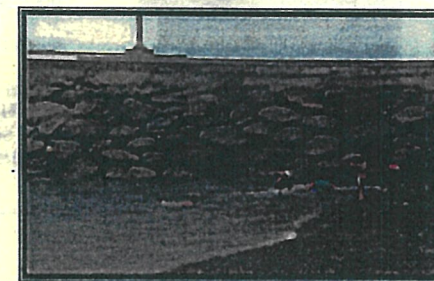
Armour rocks were found to be in large varying sizes. Only single layer of armour rocks were observed to be laid in the rock causeway. Some armour rocks are geometrically rounded in shape the made them easy to slide.

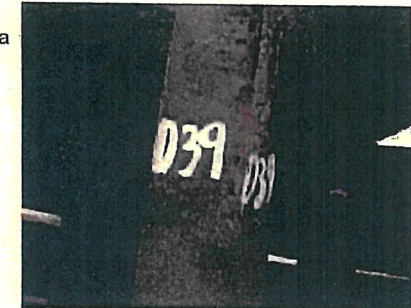
In 2008, visual inspections for the whole structures of Pier-2 were carried out. Underdeck inspection revealed the concrete spalling on the bottom surface of r.c. deck and along the longitudinal surface of the beams that made the reinforcing bars exposed to salinity. This made the steel reinforcement highly corroded. Some piles were also seen damage on the concrete surface and the reinforcing bars corroded. In 2009, detailed inspection for planning the repair scheme of each structural members was conducted. The detailed inspection include the evaluation of the degree of damage of rebars if needed to be replaced, the strength of concrete and scraping of barnacles on pile surface along the splash zone to determine the extent of the damage.
