Structural type Open type jetty		Case No. CAM-1		Inspection data		
Port	Sihanouk Ville port	Completion	1959		Component	Method
Name of facility	Old Jetty	Service start	1960		All Structure	Visual Check
Management body	Port Autonomous of Sihanouk ville	Tidal level	H.W.L	1.9	m	Date
			L.W.L	0.3	m	Aug-95
		Design water depth	-9	m

The target of the facility is Open type jetty. Which had been in service for 50 years. the old jetty consists of three part: Main jetty , access bridge , and corner junction located in between the former structures. since the Jetty P/C beam was seriously damage by the splash of waves, and lack of maintenace. After repaired work in 1996, The jetty handling only the general cargos and passenger cruise ship.

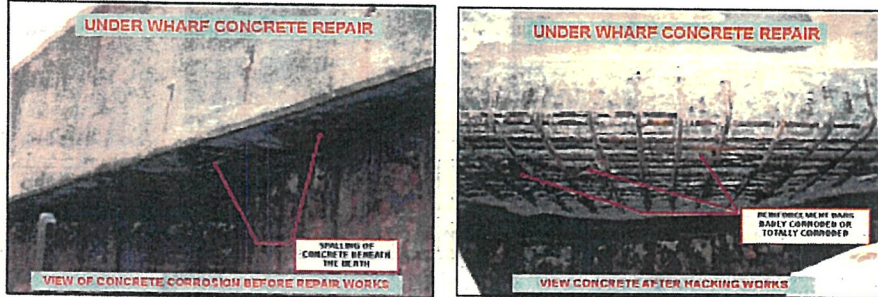
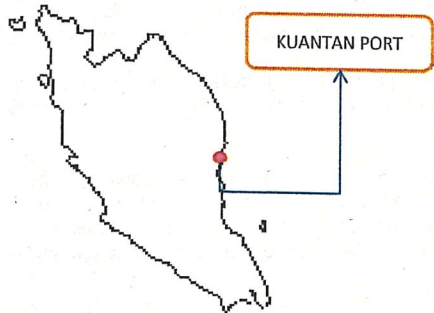
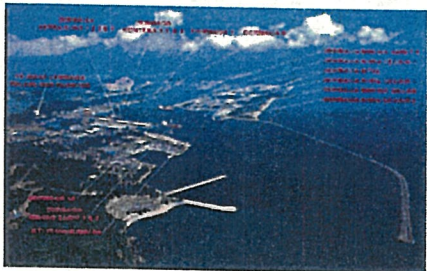
Component	Item	Deterioration grade													
Wharf	Concrete Beam	Zone 3													
	Concrete Piles														
Cross-sectional view of facility

Countermeasure and/or maintenance plan									
Outline of facility						<table border="1"> <thead> <tr> <th>Component</th> <th>Method</th> <th>Date</th> </tr> </thead> <tbody> <tr> <td>Concrete Beam</td> <td>Replacement of reinforcement bars, microconcreting</td> <td rowspan="2">2008/2009</td> </tr> <tr> <td>Concrete Piles</td> <td>and epoxy coating</td> </tr> </tbody> </table>		Component	Method	Date	Concrete Beam	Replacement of reinforcement bars, microconcreting	2008/2009	Concrete Piles	and epoxy coating
Component	Method	Date													
Concrete Beam	Replacement of reinforcement bars, microconcreting	2008/2009													
Concrete Piles	and epoxy coating														
<p>The target facility was a concrete beams Materials of beam are G40 concrete and T20 steel reinforcement. All the components were inspected in 2006/2007. Then countermeasures for keeping the performance of facility were applied to the beams and piles in 2008/2009.</p>
